SUB-COMMITTEE ON SHIP DESIGN AND CONSTRUCTION 10th session Agenda item 10

SDC 10/INF.8 13 November 2023 ENGLISH ONLY Pre-session public release: ⊠

A "near miss" safety incident with the permanent means of access

Submitted by IACS

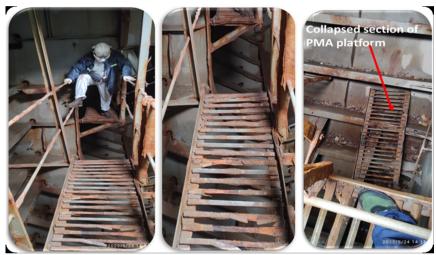
In May 2022, an IACS member's surveyor attended a 10-year-old bulk carrier in drydock for the progression of the renewal survey. The attending surveyor, together with the ship's Chief Officer, entered the No 6 top side wing water ballast tank from the main deck access opening and descended onto the upper PMA platform. Shortly thereafter, an entire section of the platform collapsed underneath the surveyor and Chief Officer (figure 1). Fortunately, no serious injuries were sustained as both persons held on tightly to the handrails and were able to make their way safely back to the access ladder and leave the tank.

Figure 1: The collapse of the PMA platform during inspections on a 10-year-old bulk carrier
