**MEASURES TO HARMONIZE PORT STATE CONTROL (PSC) ACTIVITIES AND  
PROCEDURES WORLDWIDE**

**Report on the concentrated inspection campaign for  
emergency power supply testing**

**Submitted by IACS**

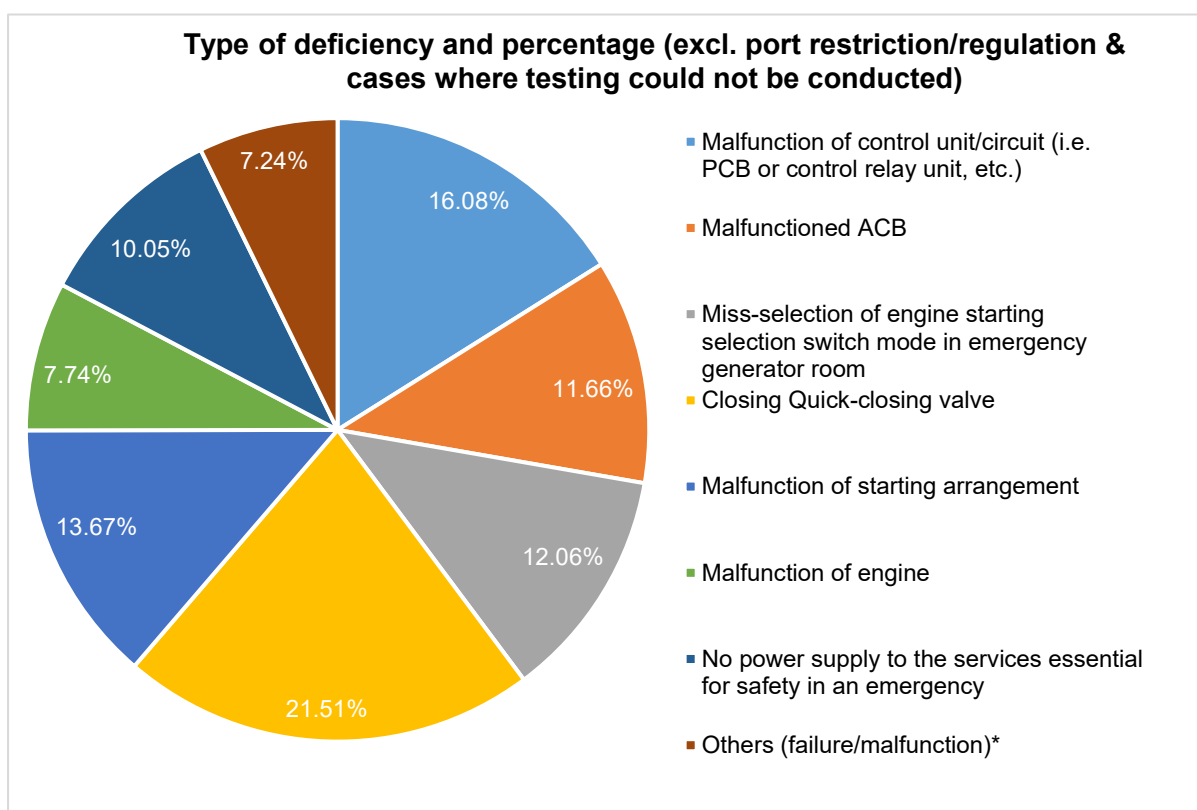
Figure 1

6 The type of deficiency and percentage (excluding port restriction/regulation and cases where testing could not be conducted) are shown in the figure below:

7 There were recurring equipment failure points of which the following are the most critical:

- .1 the closing of quick-closing valves;
- .2 control unit/circuit (PCB/relay); and
- .3 Emergency Diesel Generator (EDG) starting arrangements.

8 The recurring nature of such failures indicated industry-wide issues with equipment maintenance, installation quality or component durability. These failures directly compromise compliance with SOLAS regulations II-1/42 and II-1/43 for automatic Emergency Power Supply (EPS) activation.
