SUB-COMMITTEE ON SHIP DESIGN AND
CONSTRUCTION
12th session
Agenda item 11

**REVIEW AND, IF NECESSARY, AMENDMENT OF SOLAS REGULATIONS II-2/13.4.1.1
AND 13.4.2.1 TO CLARIFY THE REQUIREMENTS ON ESCAPE ARRANGEMENTS FROM
THE LOWER PART OF MACHINERY SPACES**

**Consideration of positive safety experience with the application of SOLAS regulations
II-2/13.4.1.1 and 13.4.2.1**

Submitted by Marshall Islands, Türkiye, Republic of Korea, United Kingdom and IACS

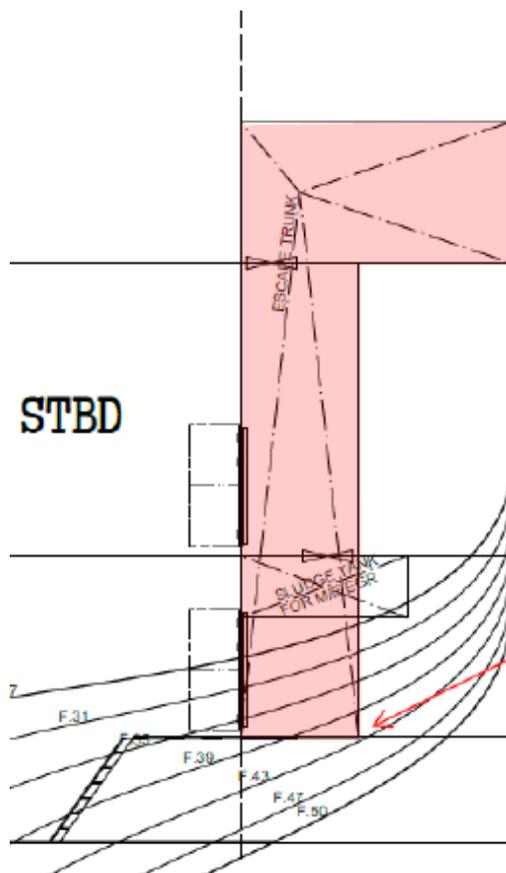
- .1 insufficient space due to any restrictions, e.g. ship's hull lines (see figure 1, below), side shell stiffening, structural design arrangements;
- .2 equipment or machinery being in the way, e.g. shaft or stern seal equipment; and,
- .3 maintenance envelope or access required to maintain equipment or withdraw shafts.

Figure 1: Example of typical practical constraints or limitations in the lower part of the space

19 These structural or technical limitations are, however, not new; it is reasonable to assume that they were present and taken into consideration as early as 1981, when the requirement for the escape trunk to extend from the "lower part of the space" was introduced in SOLAS regulations II-2/28.3.1.1.1 and II-2/45.3.1 of the 1981 Amendments to SOLAS.
