# IACS CIC for Emergency Power Supply Testing – 2025 Report (Rev.1)

## 1. Background

IACS agreed to conduct a Concentrated Inspection Campaign (CIC) which was held for 12 months commencing from 1 January 2025 and ending 31 December 2025 to examine the Emergency Power Supply of the ship. A ship was subject to only one inspection under this CIC during the period of the IACS campaign.

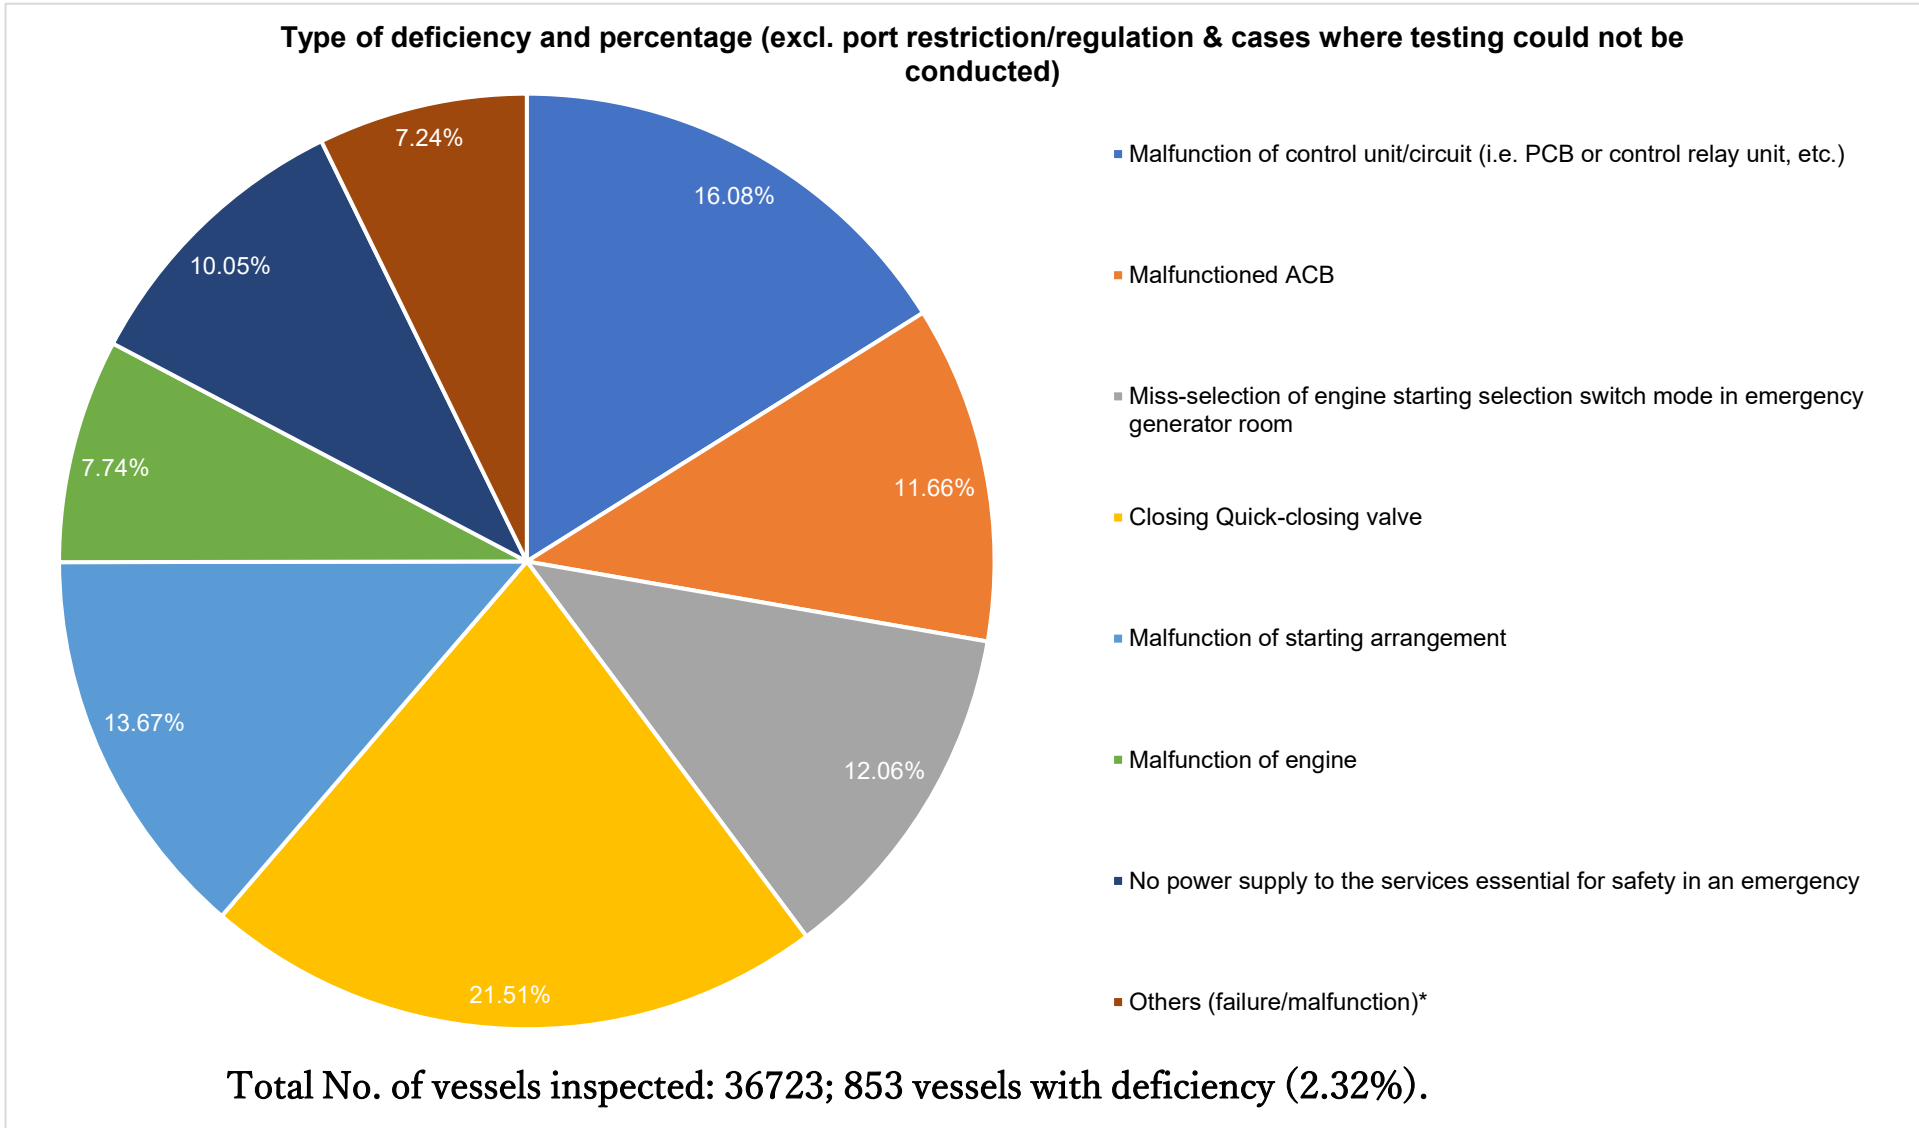
3.Type of deficiency and percentage (excl. port restriction/regulation & cases where testing could not be conducted) are shown in the figure below:

The closing quick-closing valve, control unit/circuit (PCB/relay), and Emergency Diesel Generator(EDG) starting arrangement are the most critical and recurring failures which indicating industry-wide issues with equipment maintenance, installation quality, or component durability. These failures directly compromise SOLAS Ch. II-1 Reg. 42/43 compliance for automatic Emergency Power Supply (EPS) activation.
